# Lift Injuries – More Than a Drop In the Bucket

Terry Bunn, Medearis Robertson

Kentucky Injury Prevention and Research  
Center, College of Public Health, University  
of Kentucky

# Falls from Lifts

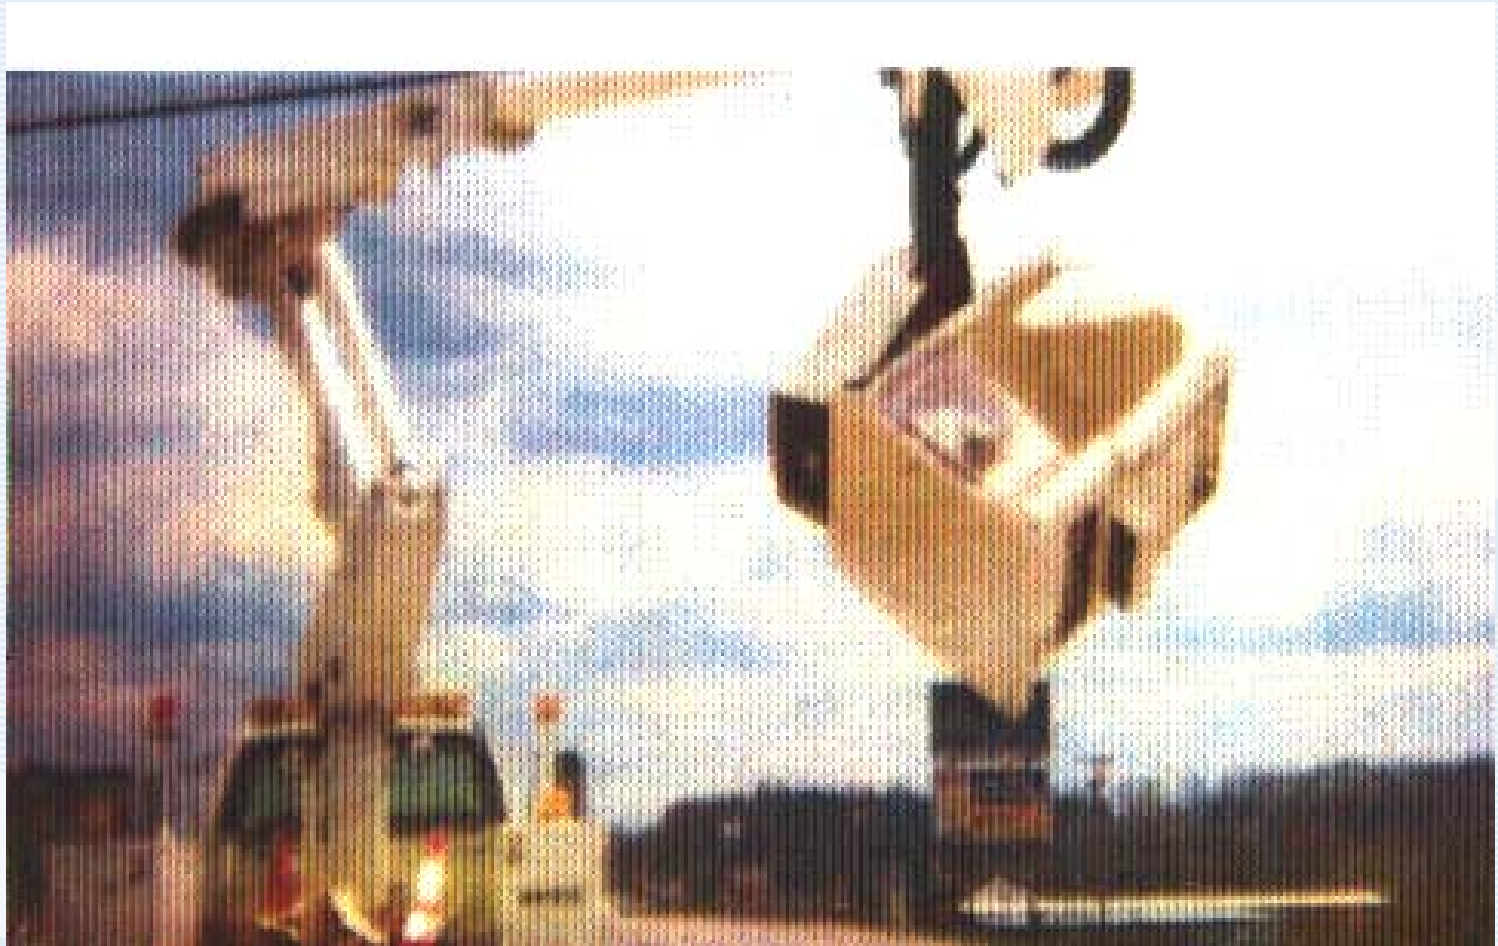
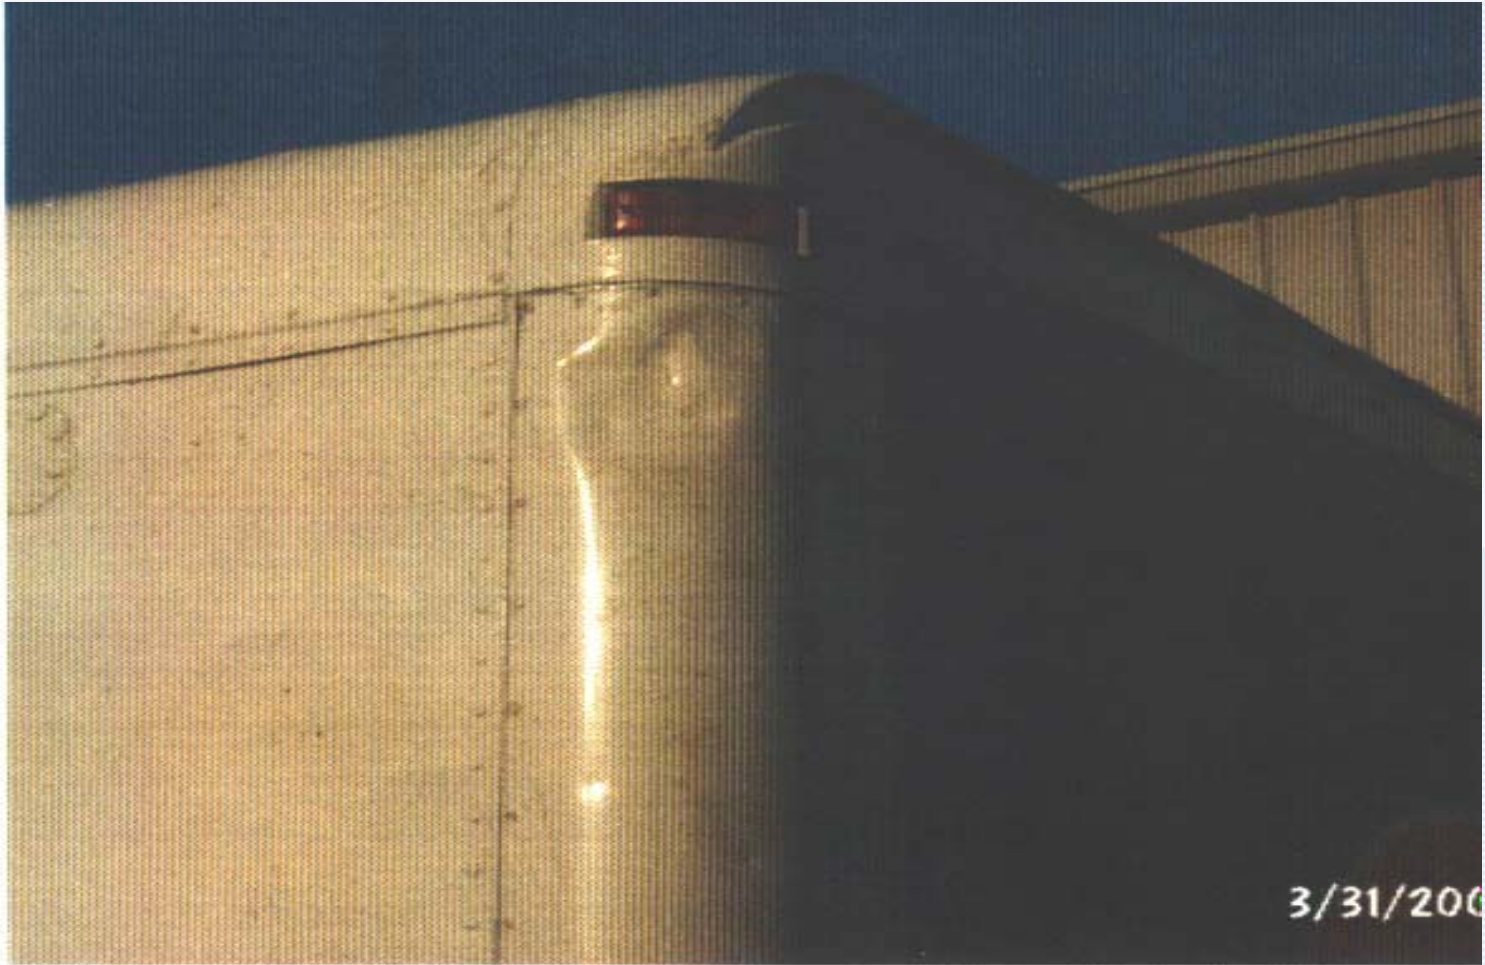
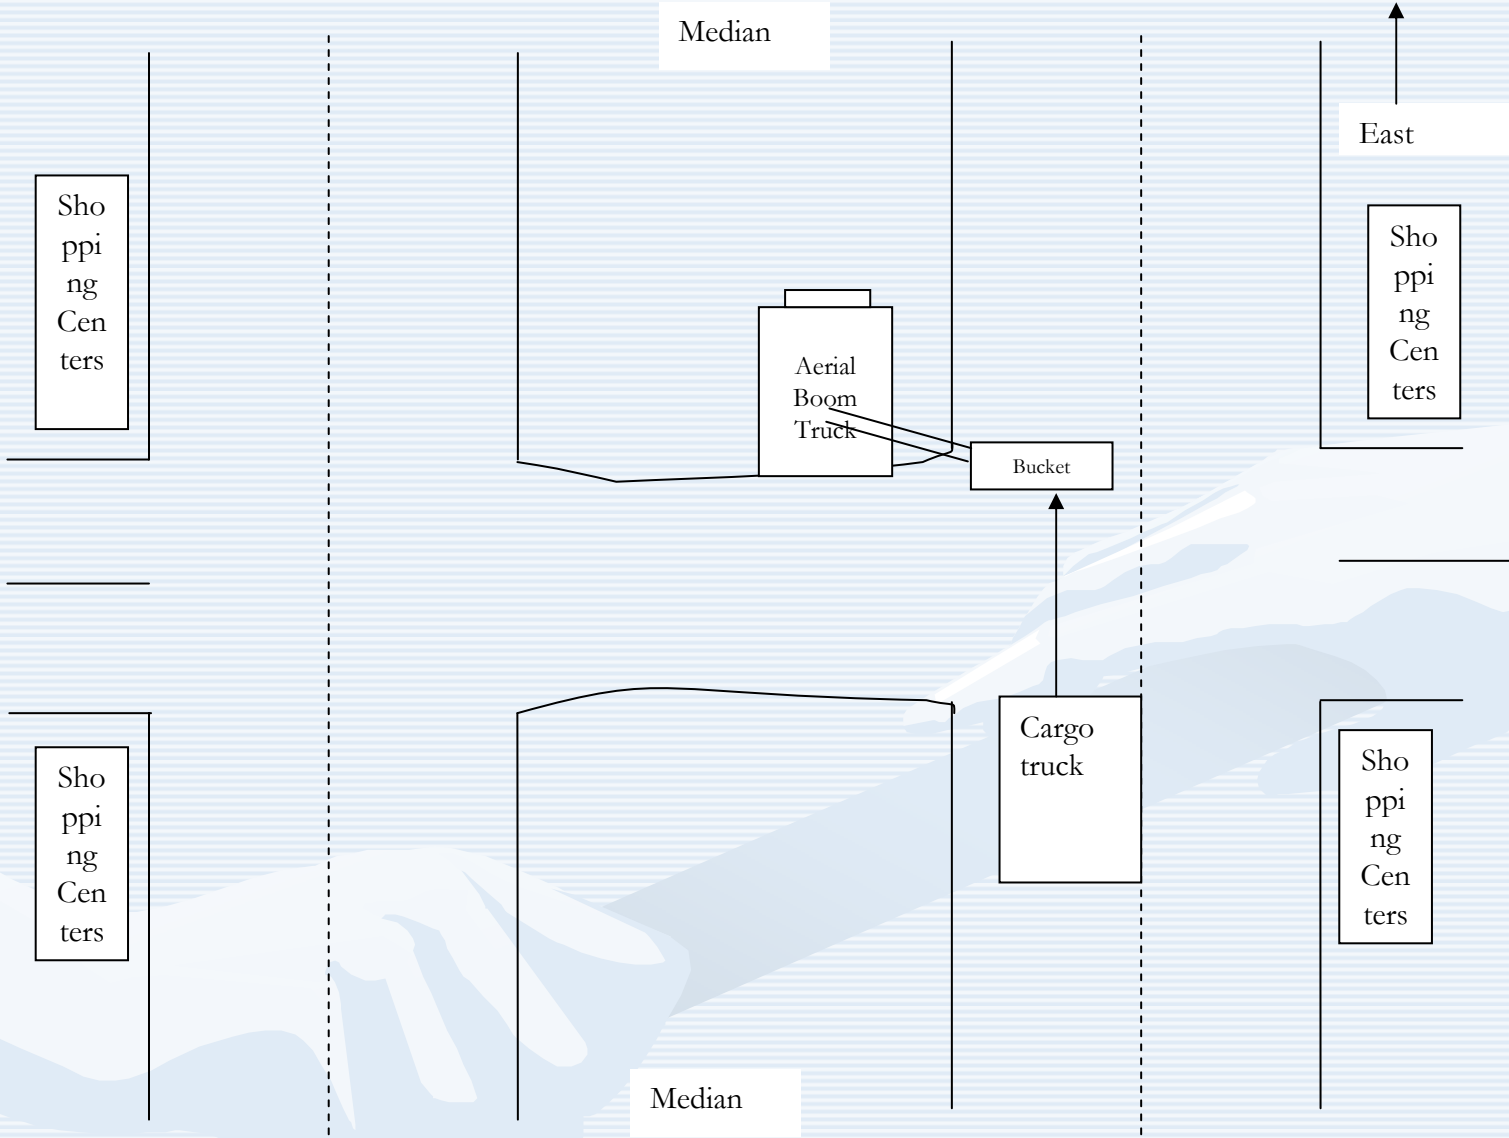
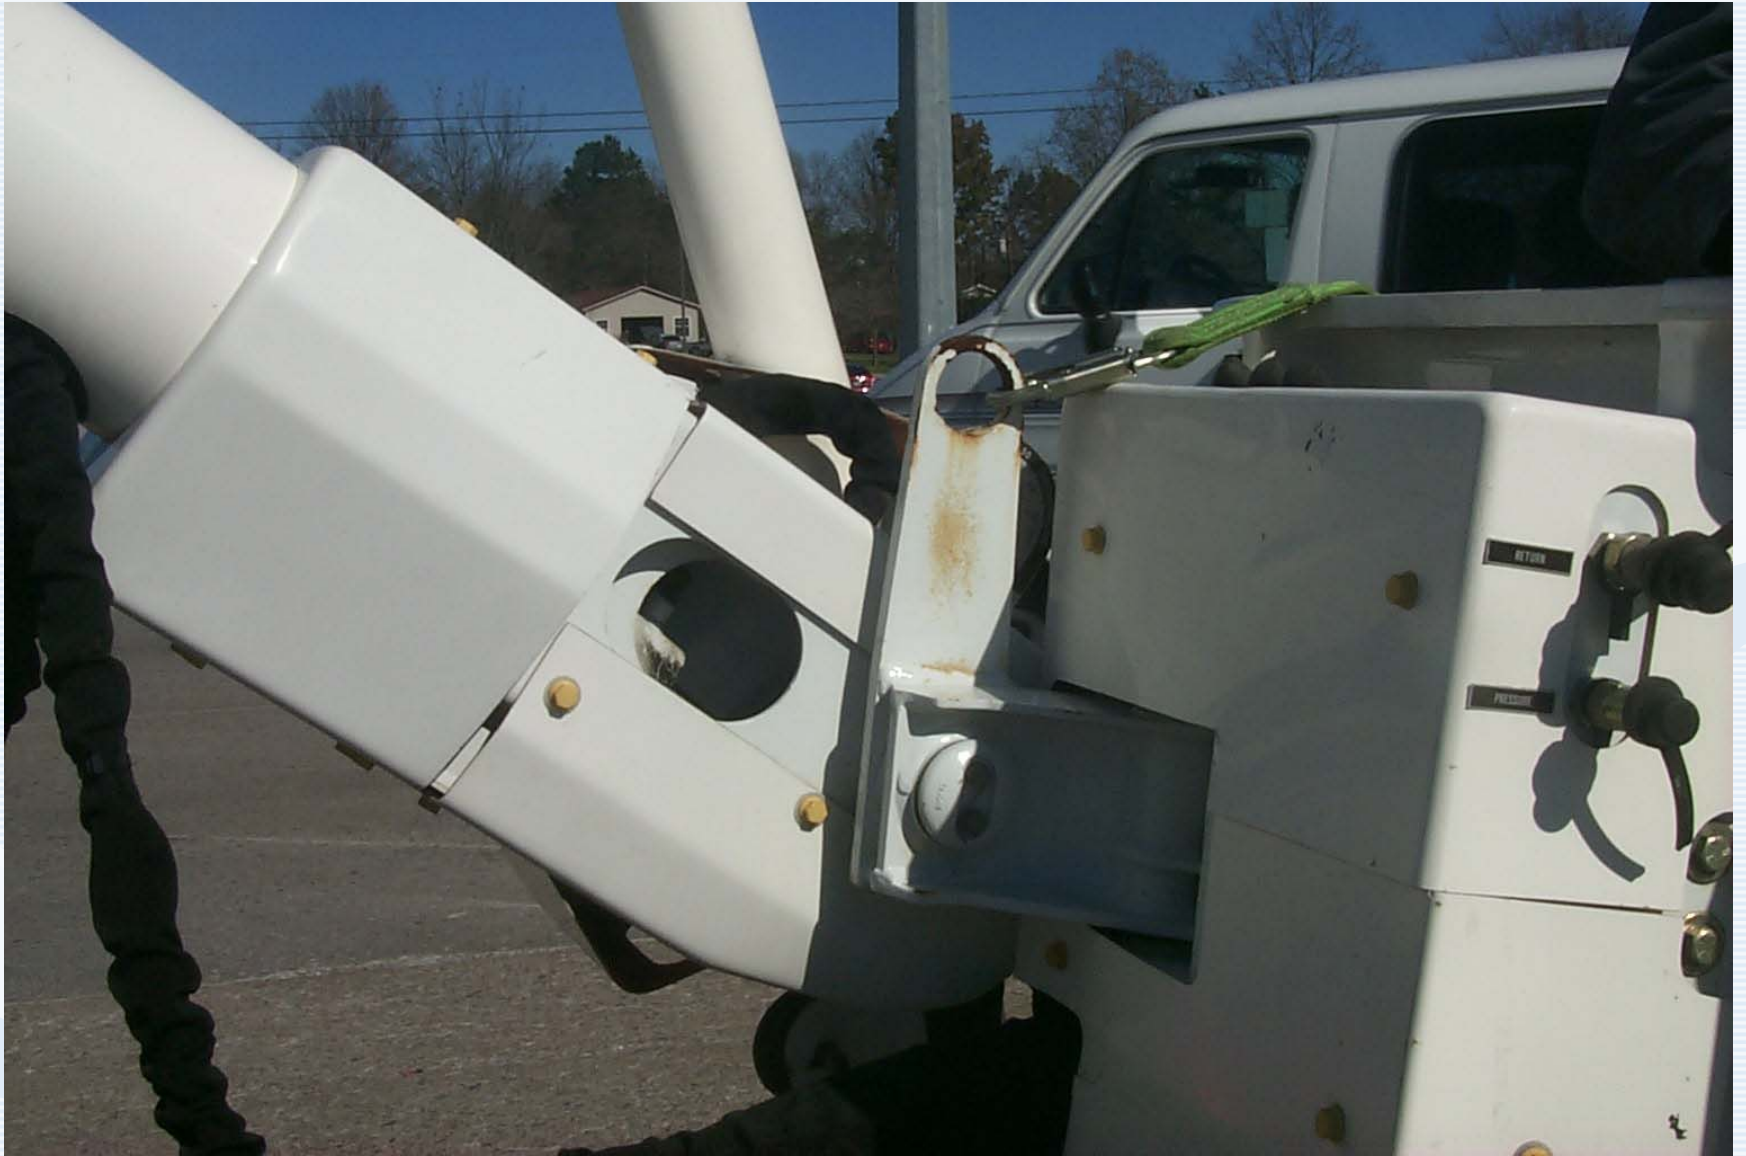
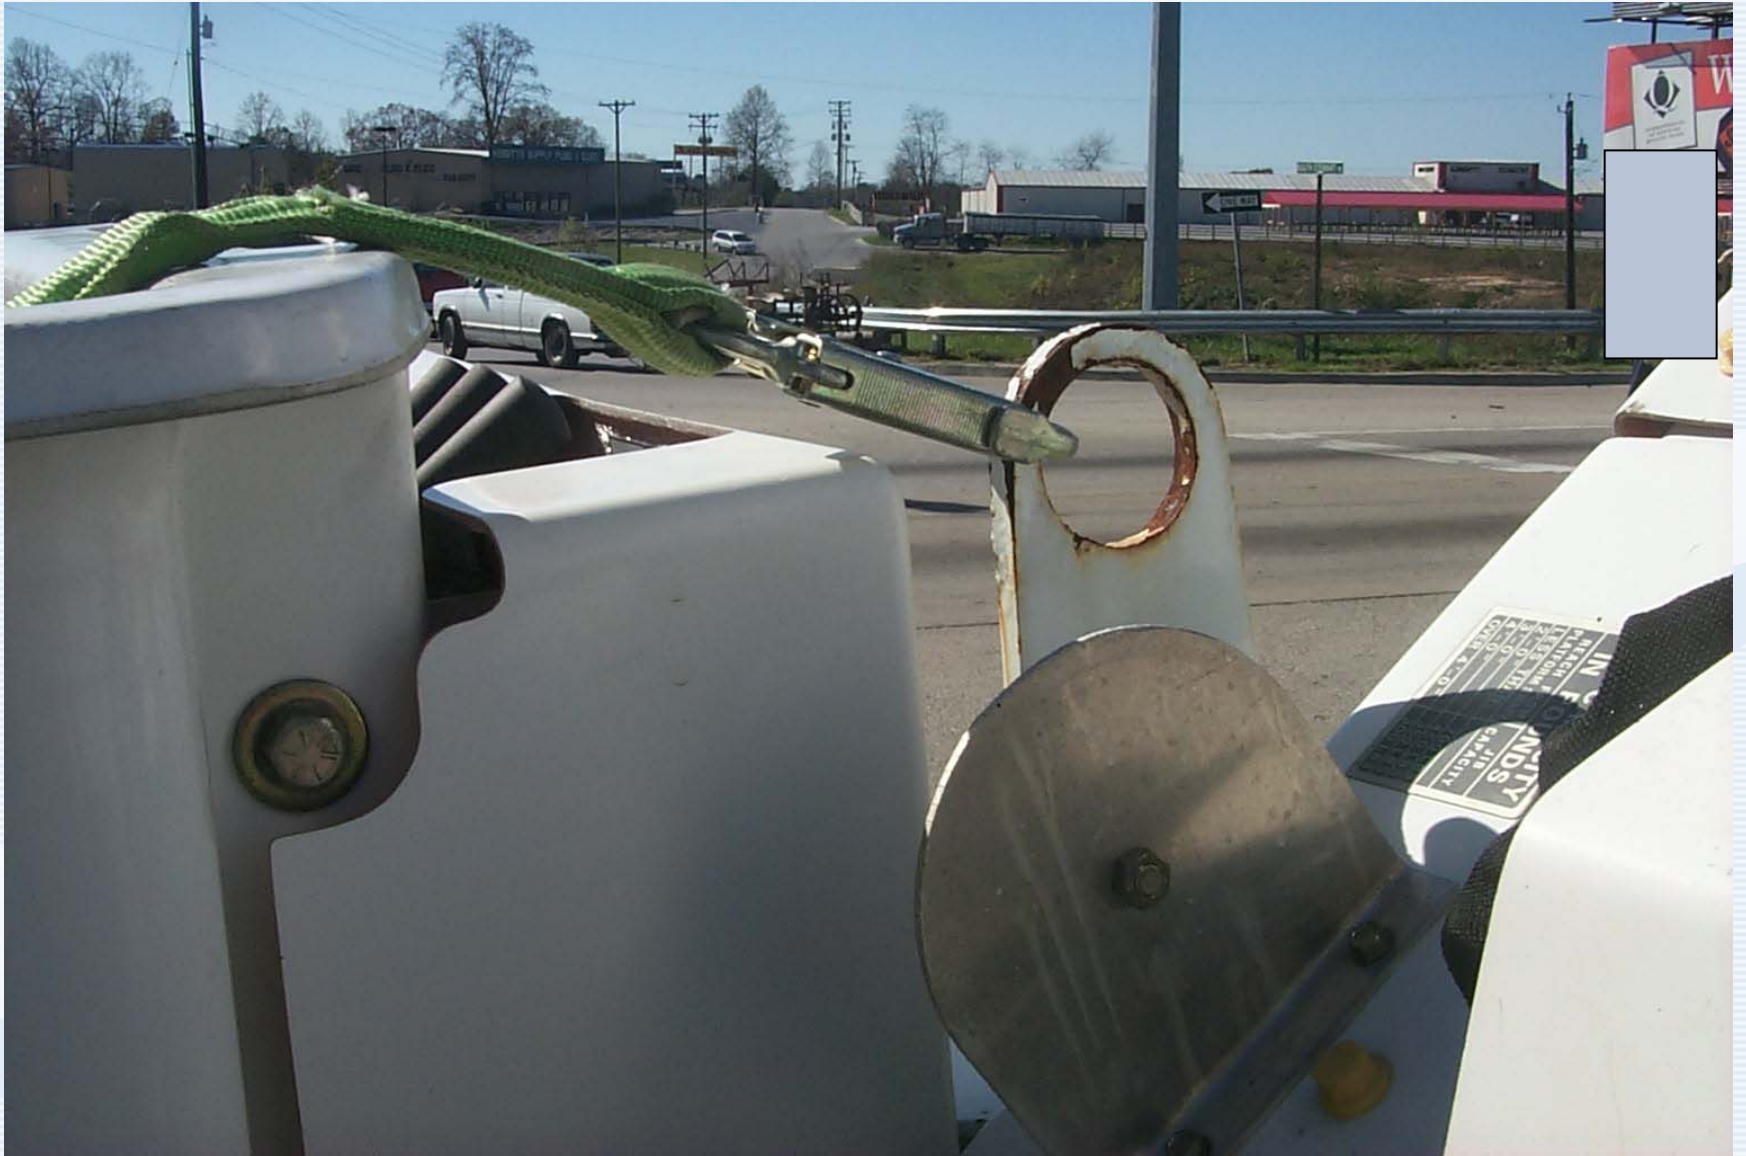
**Traffic Technician Dies  
From Fall While Changing  
Traffic Signal Bulb  
Incident Number: 03KY028**

On Monday, March 31, 2003, a 39 year-old male (decedent) highway traffic technician, working alone, received fatal head injuries after falling out of an aerial boom truck. The injuries from the fall resulted in his death four days later. He was changing a burned-out green traffic bulb in a traffic signal suspended over 2 lanes of traffic. As he worked from the aerial lift suspended over traffic to change the burned out bulb, a cargo truck drove underneath the bucket, striking it, and spilling the decedent to the asphalt below. As the worker fell approximately 10 feet, an eye witness called emergency services. Paramedics arrived within minutes and transported the technician to a nearby hospital. From there, the technician was airlifted to a trauma level hospital where he died 4 days later due to head injuries received from the fall.

# **Recommendation No. 1: Employees should use personal fall protection equipment in an aerial lift bucket at all times.**

- Employers have a responsibility to provide a safe working environment for all their employees. Employees have a responsibility to themselves and to their employer to use all applicable safety training and personal fall protection equipment provided by the employer. The safety harness was not worn at the time of the incident. There were two other harnesses in the truck provided by the truck manufacturer which had not been used and only needed adjustment to fit the user.

## **Recommendation No. 2: A Competent person should conduct a hazard assessment of the highway work zone and implement a safety plan.**

- There are several methods of working safely while changing the traffic signal. Besides wearing appropriate personal fall protection, the traffic lane(s) over which the bucket is suspended should be clear of all traffic and remain clear until the worker is back to a safe place. This eliminates the worker or drivers estimating if there is enough space under a bucket to pass safely by. According to highway personnel it takes approximately 2 light changes to change a green bulb. During this time, traffic can be routed into the next lane around the bucket, or the traffic can be stopped while the light bulb is changed. Cones should be placed around the work zone prior to work beginning to warn motorists of an upcoming work zone area and to direct them to the unoccupied lane, and to proceed with caution. Traffic in the work zone lane could have been closed off. To inform motorists of the lane closure, A Shadow Vehicle, equipped with flashing or rotating lights and an appropriate directional arrow could also have been used.

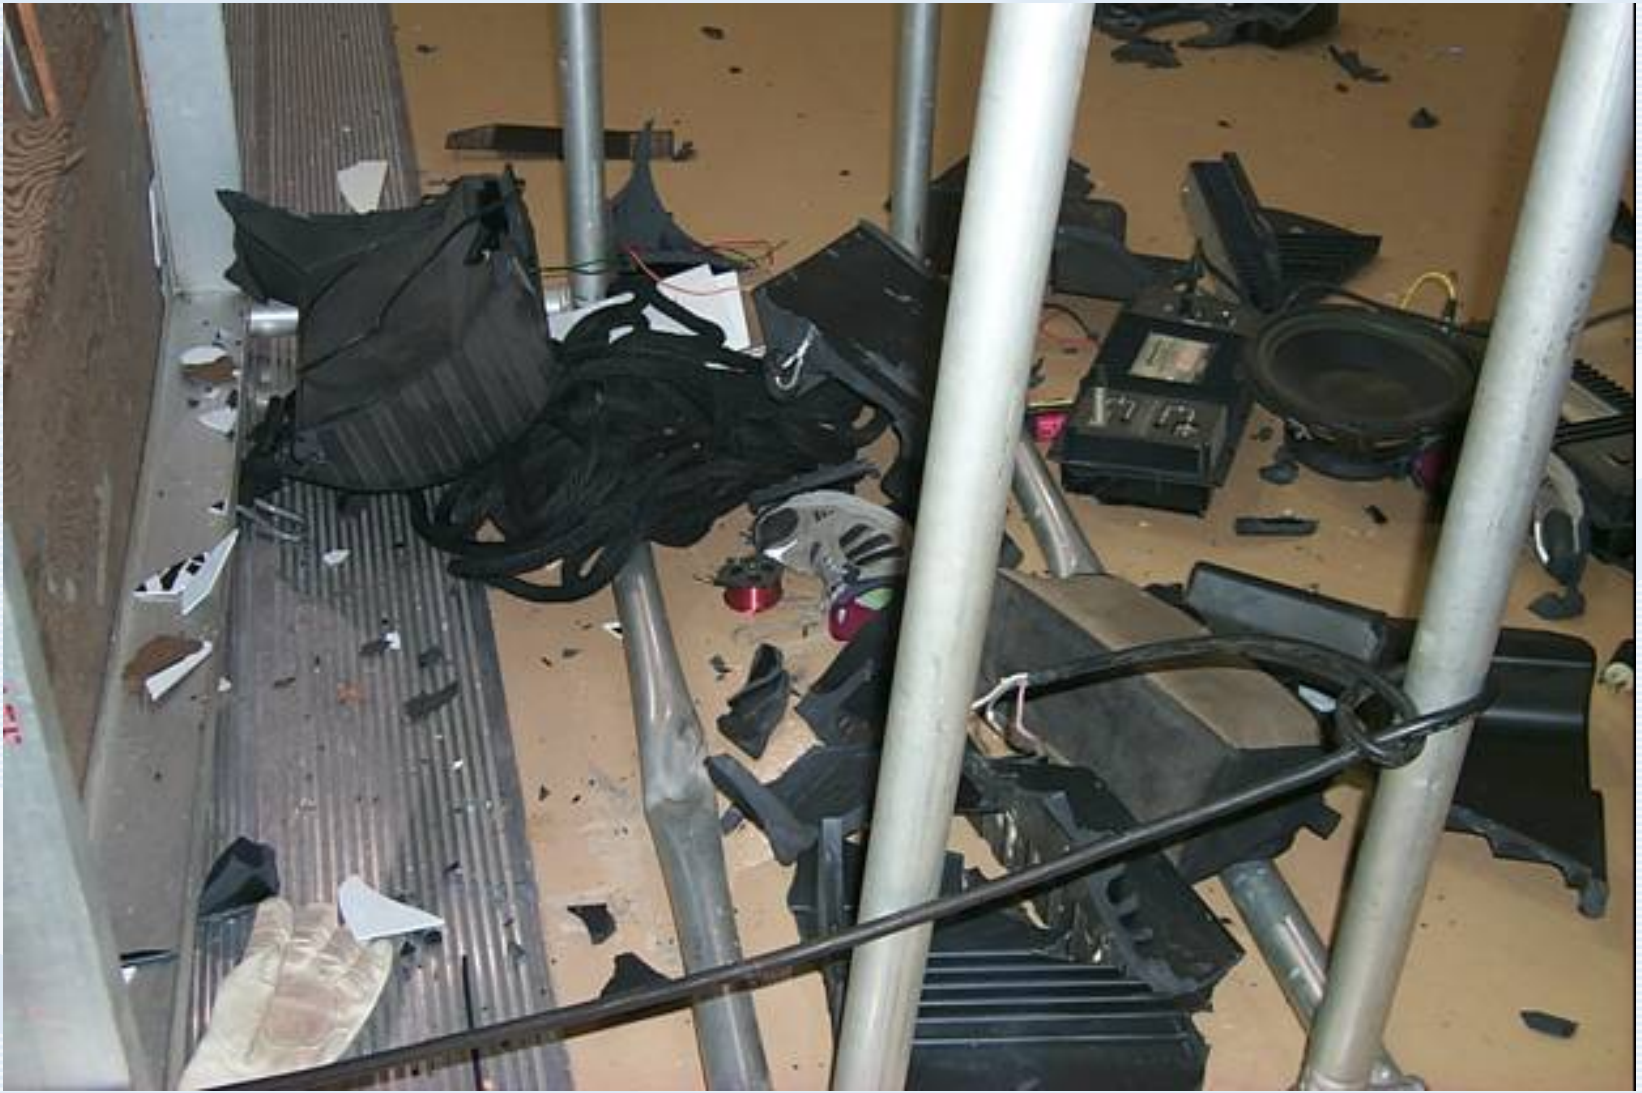
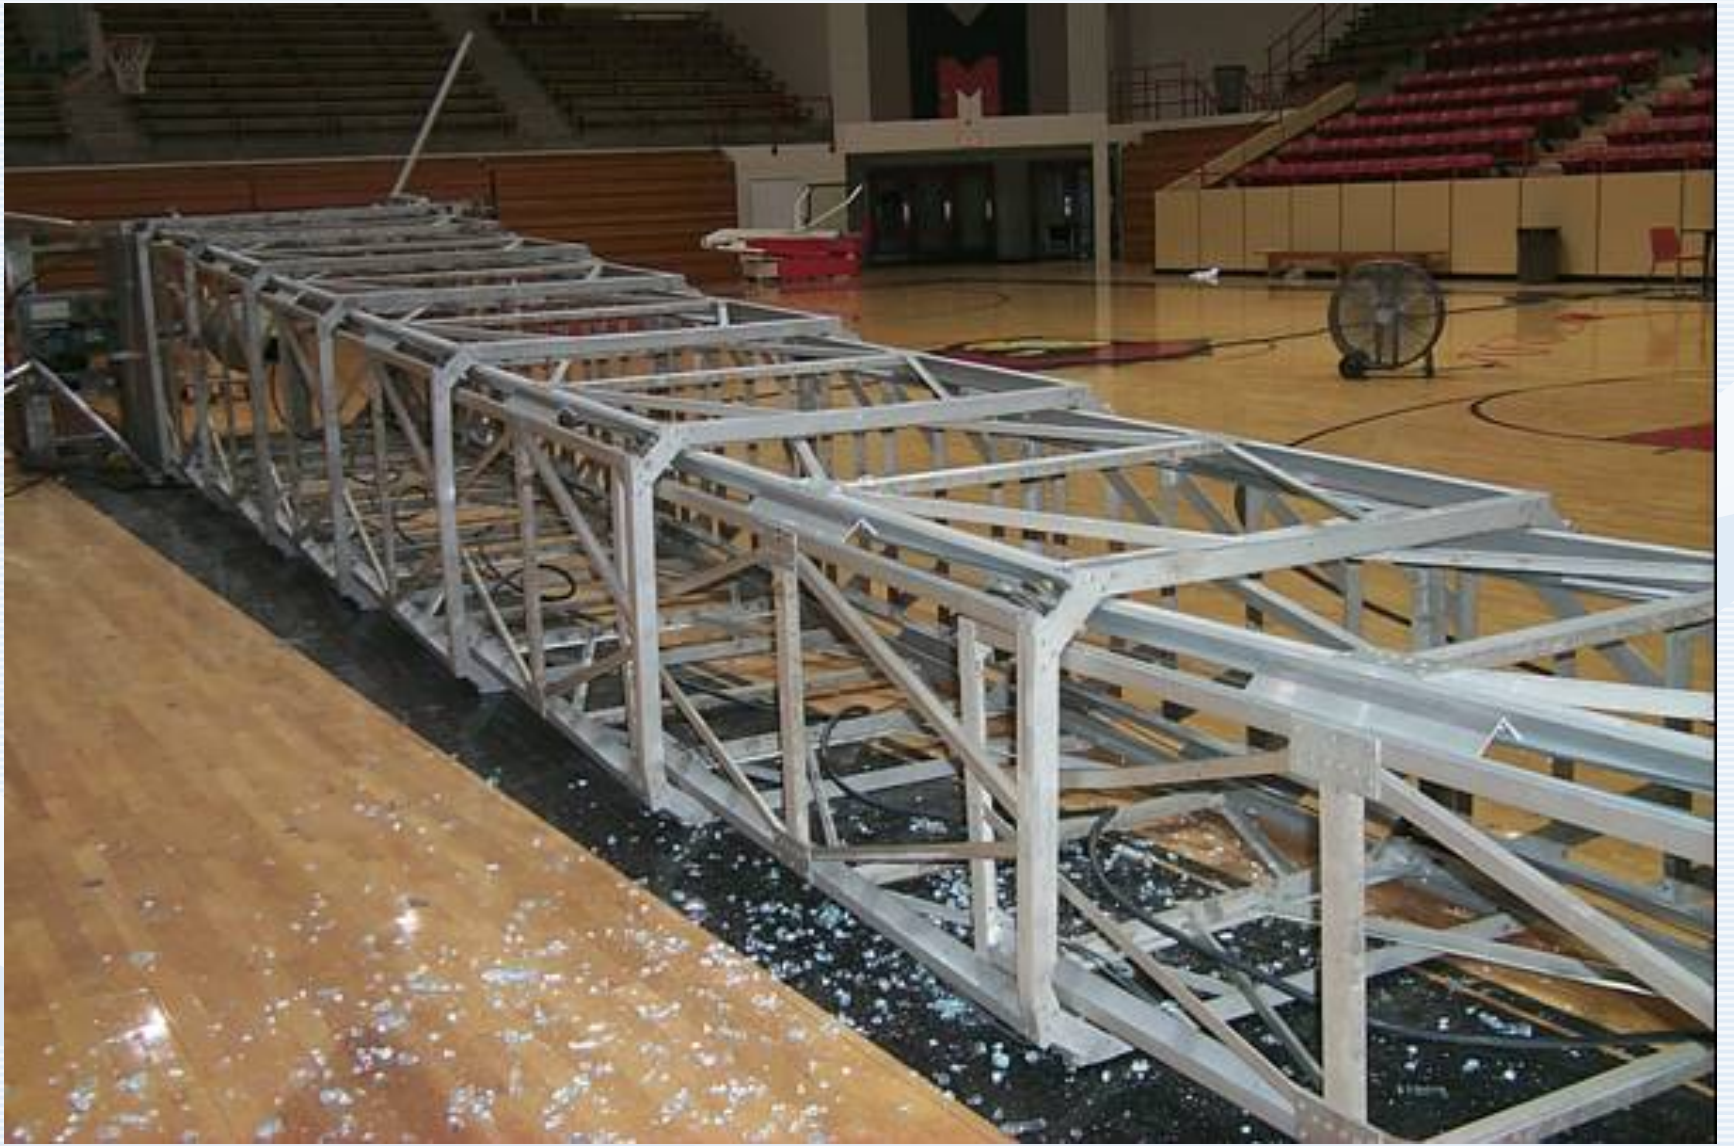
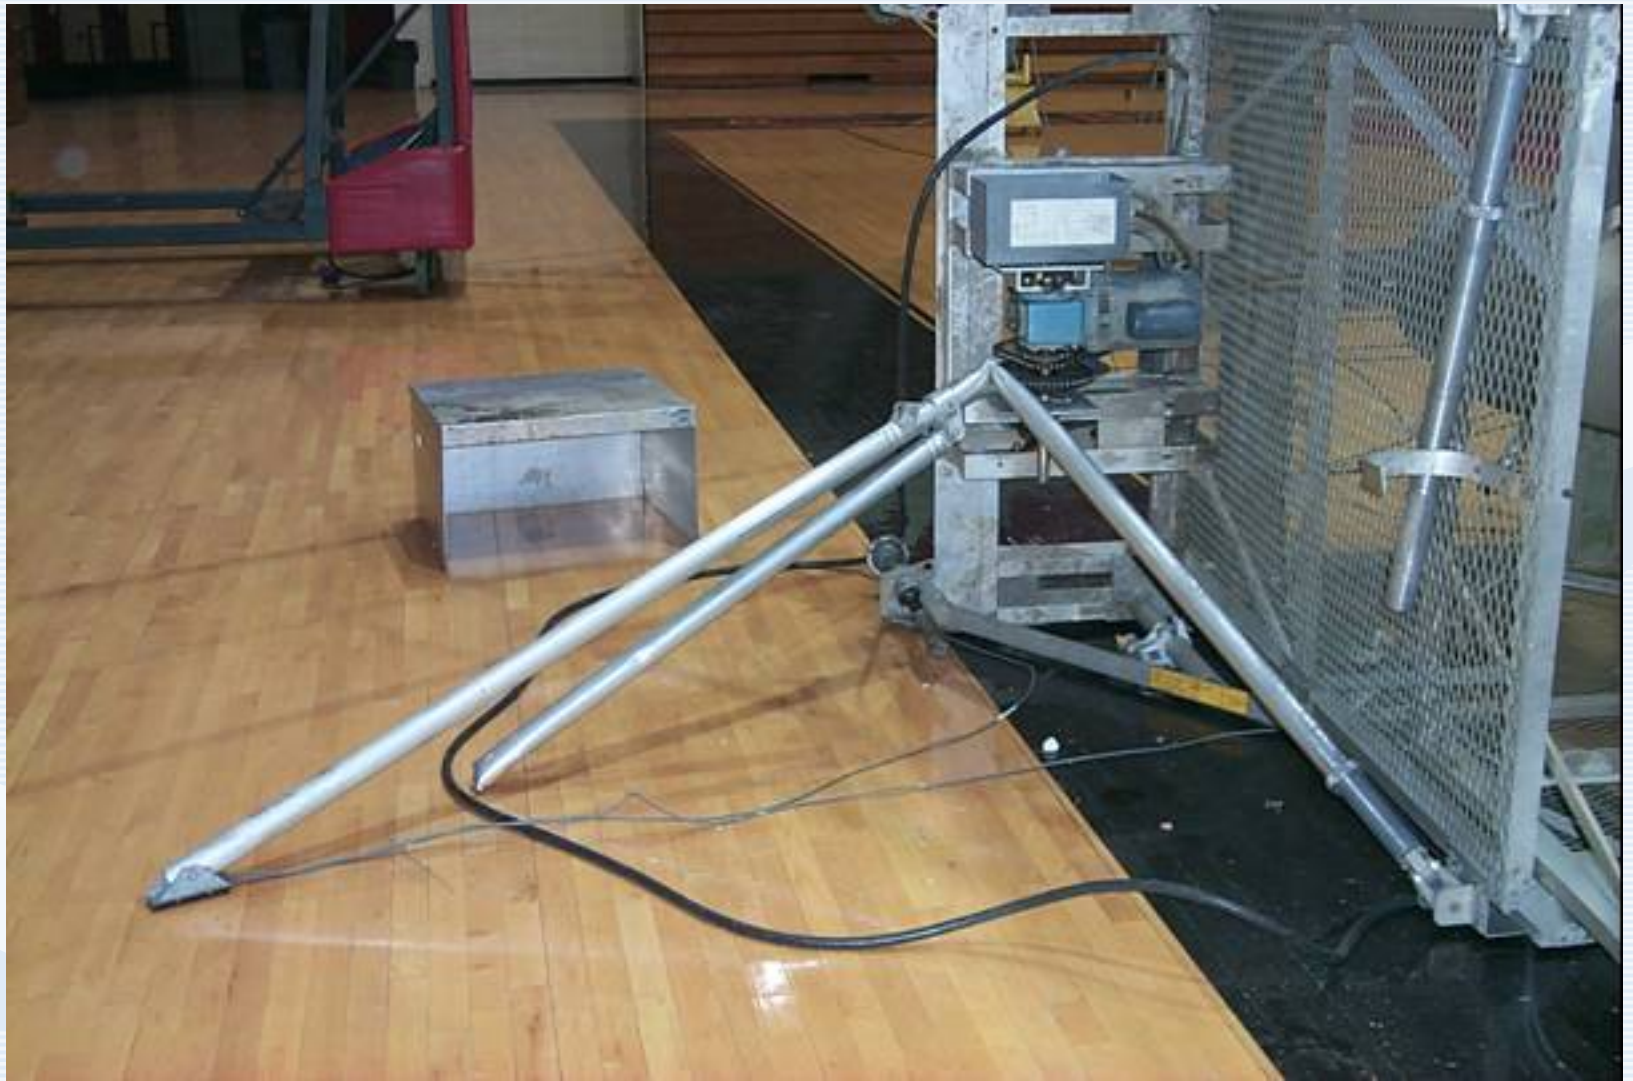
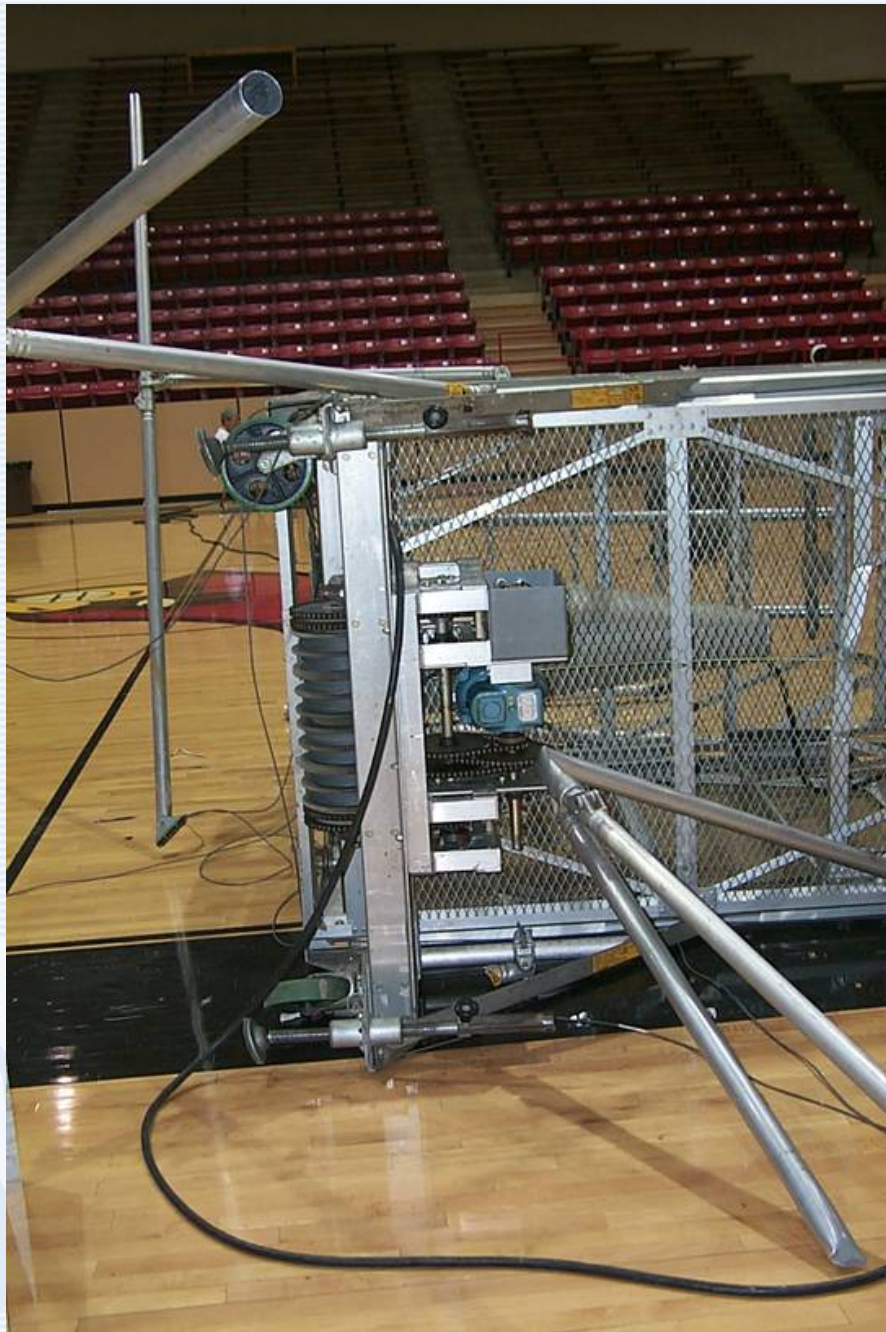
# 28-Year-Old Man Dies after Falling with Lift

On June 27, 2003, a 28-year-old male sound technician died due to injuries received after falling approximately 50 feet from a lift. Three men (one chief sound engineer and two sound technicians) were sent to repair a sound system in a school gymnasium. Upon arriving and assessing the situation, the three diagnosed that a particular speaker, located in the rafters, should be removed from its location. Using a 30-year-old telescoping, self-leveling lift belonging to the school, the chief engineer used controls located at the base of the lift, to hoist the two sound technicians to the speaker in the rafter. After determining which tools they needed to remove the speaker, the chief engineer lowered the two men to the ground. They retrieved the appropriate tools from their equipment truck and proceeded to be hoisted a second time to the speaker. After removing the speaker from the rafter, the two sound technicians placed the speaker in the middle of the lift's basket and the chief engineer reversed the direction of the lift and began to lower the two men and the speaker to ground level. Shortly after the lift began to descend, it started to tilt to the east side of the gym. The lift continued its fall to the ground. Both sound technicians were critically injured and transported to a hospital where one survived and the other died of multiple blunt force trauma.

The lift involved in this fatality was purchased prior to 1970.

Maintenance records for the lift were unavailable at the time of this investigation and thought not to exist. Owners of equipment should follow the manufacturer's recommendations on operating and maintenance and inspection schedules.

According to several lift equipment manufacturers, the metal cables of the lift required regular greasing in order to keep the lift functional.

## **Recommendation #1: Training of supervisors and employees on equipment should include, but not be limited to: load capacity, work height, use of outriggers, and weight calculations.**

A competent person should be trained in calculation of the load capacity for lift equipment and be knowledgeable of work heights and outriggers. KY OSH Standard 1910.29(a)(3)(i) states the work height of a mobile work platform should be no more than four times the base and when this is not possible, outriggers should be used. It is believed that the combined weight of the two workers and the speaker were below the 500 pound limit of the platform of the lift. The outriggers had also been used, but it is unknown if they had been extended to an adequate distance to compensate for the additional height of the lift.

**Recommendation #2: All equipment should be maintained on a regular basis and maintenance records kept up-to-date. If equipment is borrowed, the borrower should inspect these records prior to using the equipment and receive appropriate safety training pertinent to the equipment.**

## **Recommendation No. 3: Older equipment should be inspected to ensure it complies with the latest requirements of the American National Safety Institute and the Occupational Safety and Health Administration Standards.**

According to OSHA 1910.67(b), aerial lifts acquired before July 1, 1975 had to meet ANSI A92.2-1969 requirements. If the equipment did not meet the ANSI A92.2-1969 requirements, the company had the choice to modify it so it did meet the requirements or choose to not use the equipment again. In researching this particular lift design and speaking with several lift manufacturers, lifts are now designed to be more stable.
